DEPARTMENT OF TRANSPORTATION

Quality Assurance and Source Inspection

Contract #: 04-0120F4Cty: SF/ALA Rte: 80 PM: 13.2/13.9File #: 99.28**WELDING INSPECTION REPORT****Resident Engineer:**Siegenthaler, Peter**Address:** 333 Burma Road**City:** Oakland, CA 94607**Report No:** WIR-019477**Date Inspected:** 23-Jan-2011**Project Name:** SAS Superstructure**OSM Arrival Time:** 700**Prime Contractor:** American Bridge/Fluor Enterprises, a JV**OSM Departure Time:** 1900**Contractor:** Zhenhua Port Machinery Company, Ltd (ZPMC)**Location:** Shanghai, China**CWI Name:** Li Yang and Zhu Zhong Hai**CWI Present:** Yes No**Inspected CWI report:** Yes No N/A**Rod Oven in Use:** Yes No N/A**Electrode to specification:** Yes No N/A**Weld Procedures Followed:** Yes No N/A**Qualified Welders:** Yes No N/A**Verified Joint Fit-up:** Yes No N/A**Approved Drawings:** Yes No N/A**Approved WPS:** Yes No N/A**Delayed / Cancelled:** Yes No N/A**Bridge No:** 34-0006**Component:** OBG Trial Assembly**Summary of Items Observed:**

Orthotropic Box Girder (OBG) at Trial Assembly Areas

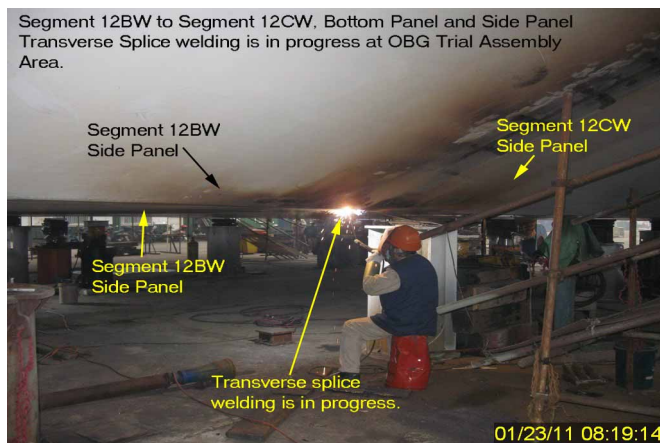
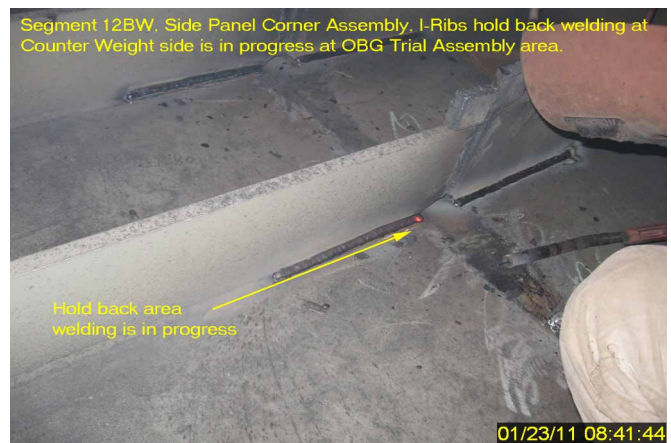
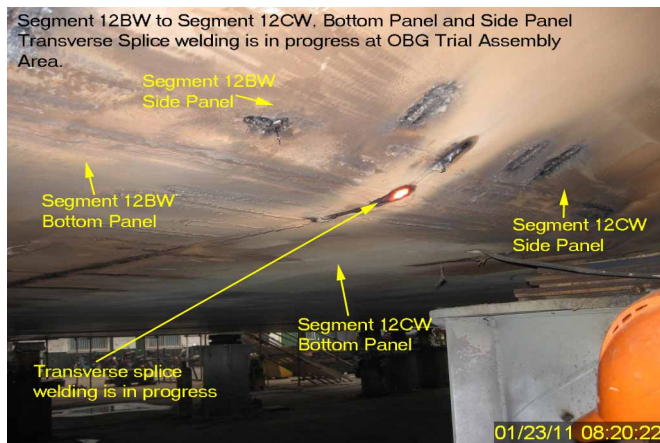
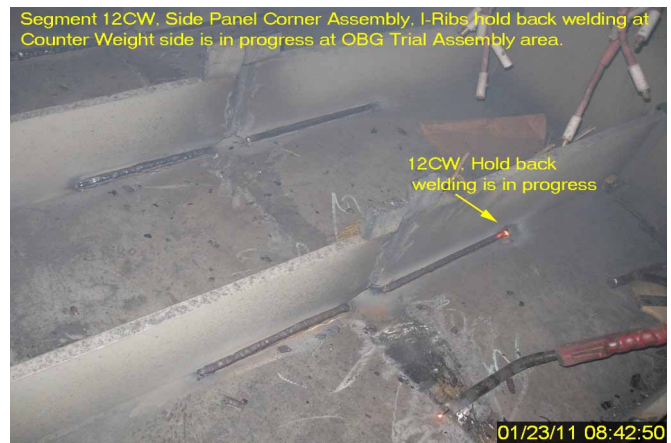
This QA Inspector observed the in-process welding by Shielded Metal Arc Welding (SMAW) process on a Complete Joint Penetration (CJP) groove weld. The Weld joint was designated as OBW12B-001. The welder identification was 040611, observed welding in the 4G (Overhead) position using approved Welding Procedure Specification WPS-B-P-2214-B-U2-FCM-1. The piece mark was identified as the Bottom Panel, at transverse splice at work point W4.

This QA Inspector observed the in-process welding by Shielded Metal Arc Welding (SMAW) process on a Complete Joint Penetration (CJP) groove weld. The Weld joint was designated as OBW12B-001. The welder identification was 057333, observed welding in the 4G (Overhead) position using approved Welding Procedure Specification WPS-B-P-2214-B-U2-FCM-1. The piece mark was identified as the Bottom Panel, at transverse splice at work point W3.

This QA Inspector observed the in-process welding by Shielded Metal Arc Welding (SMAW) process on a Complete Joint Penetration (CJP) groove weld. The Weld joint was designated as SP3051-001-042. The welder identification was 046709 observed welding in the 4G (Overhead) position using approved Welding Procedure Specification WPS-B-P-2214-B-U2-FCM-1. The piece mark was identified as the Side Panel Corner Assembly, T-Rib splice, Counter Weight side.

This QA Inspector observed the in-process welding by Flux Cored Arc Welding (FCAW) process on a Fillet weld. The Weld joint was designated as SP3057-001-022/023. The welder identification was 053486 observed welding in the 2F (Horizontal) position using approved Welding Procedure Specification WPS-B-T-2132-ESAB. The piece mark was identified as the Side Panel Corner Assembly, I-Rib splice, Counter Weight side.
